THE HOME INSPECTORS TIP SHEET

ZINSCO & SYLVANIA ELECTRIC PANELS

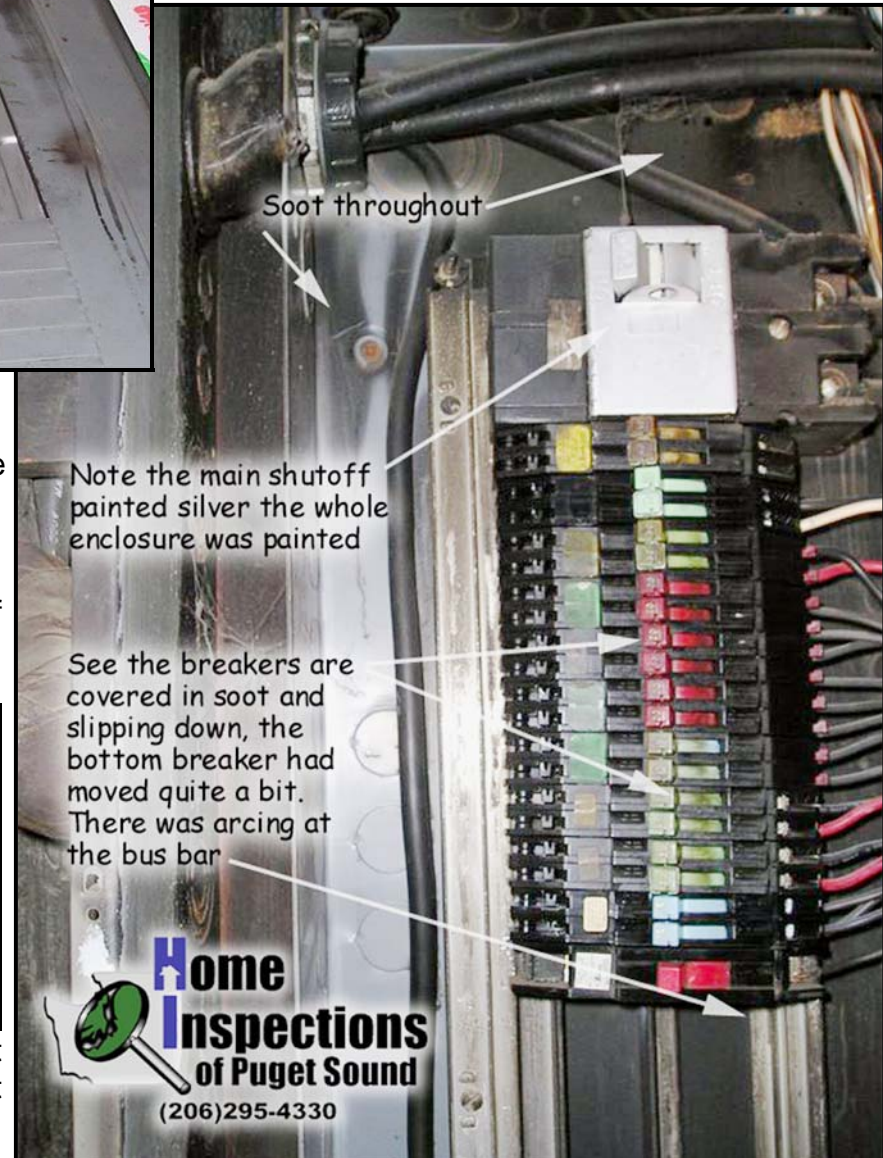
These are sample tags on the breakers inside.
