THE HOME INSPECTORS TIP SHEET

ZINSCO & SYLVANIA ELECTRIC PANELS

The Zinsco panel is one of the most common brands of dangerous electrical equipment we see

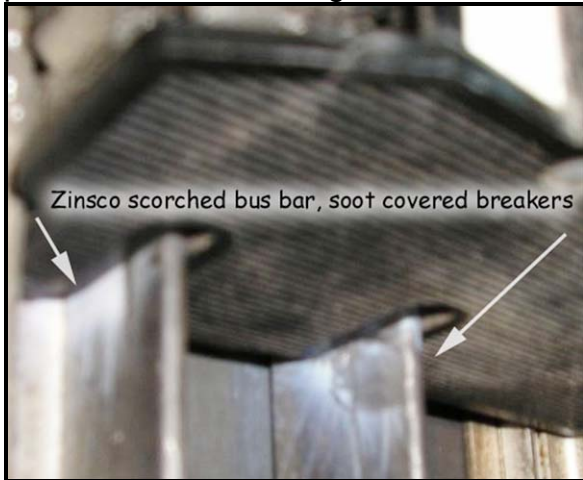
They have been manufactured with aluminum bus bars and poor connection clips at the breakers. It is the bus bar and breaker contact points arcing and overheating that have caused many of the problems with this design.

All breakers have very carefully calibrated springs and other components. Arcing where these breakers contact the bus is a common problem with this design. This can result in the overheating and incapacitation of the breakers. We have seen these breakers with their cases blown out and leaving soot on the inside of the enclosures.

Another problem with this equipment is the breakers have no positive locking position in the panel. Instead, they have a smooth bus bar to attach to, and they will sometimes slip down. When the breakers slip, they arc, carbonize and build up resistance. This resistance causes more heating resulting in breaker failure and/or possible fire.

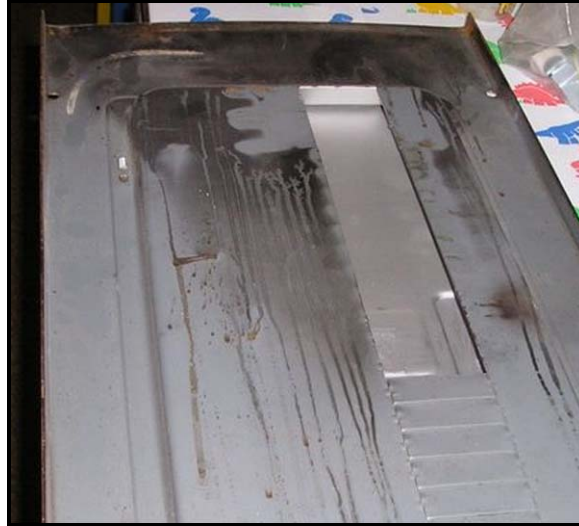
This is a panel that we inspected; note my fingerprints in the soot on the cover.

This panel was one of the most dangerous ones we have seen yet. I knew it would be a mess when we saw the seller had painted the enclosure a nice clean silver. It was full of soot and charred wires.

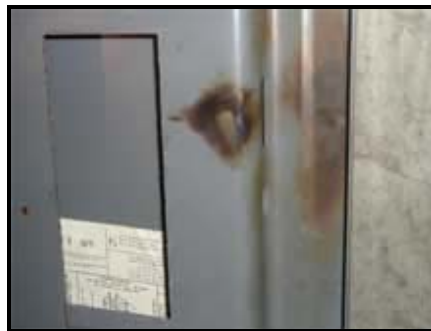
This is another panel with soot inside. There was a blown out breaker in this panel.

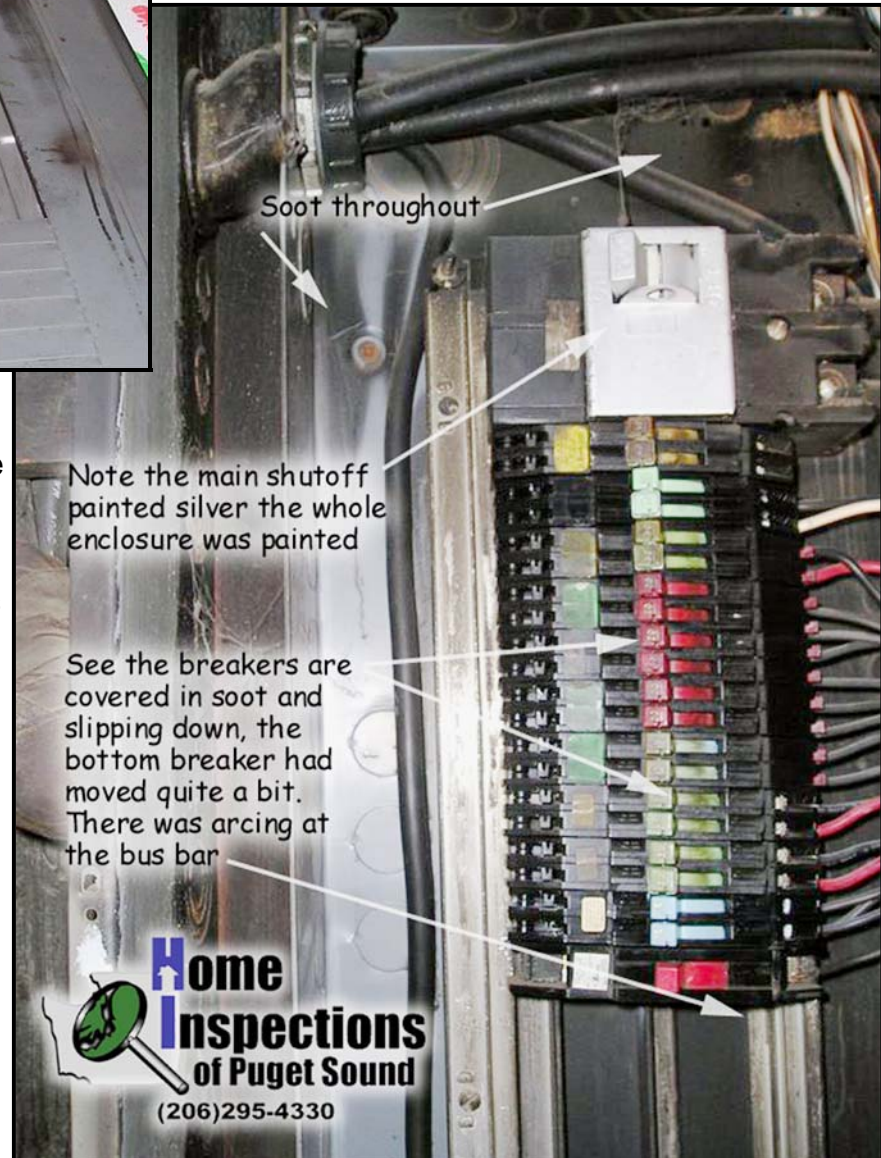
These are sample tags on the breakers inside.
